PACE

PATHFINDER CLEAN ENERGY

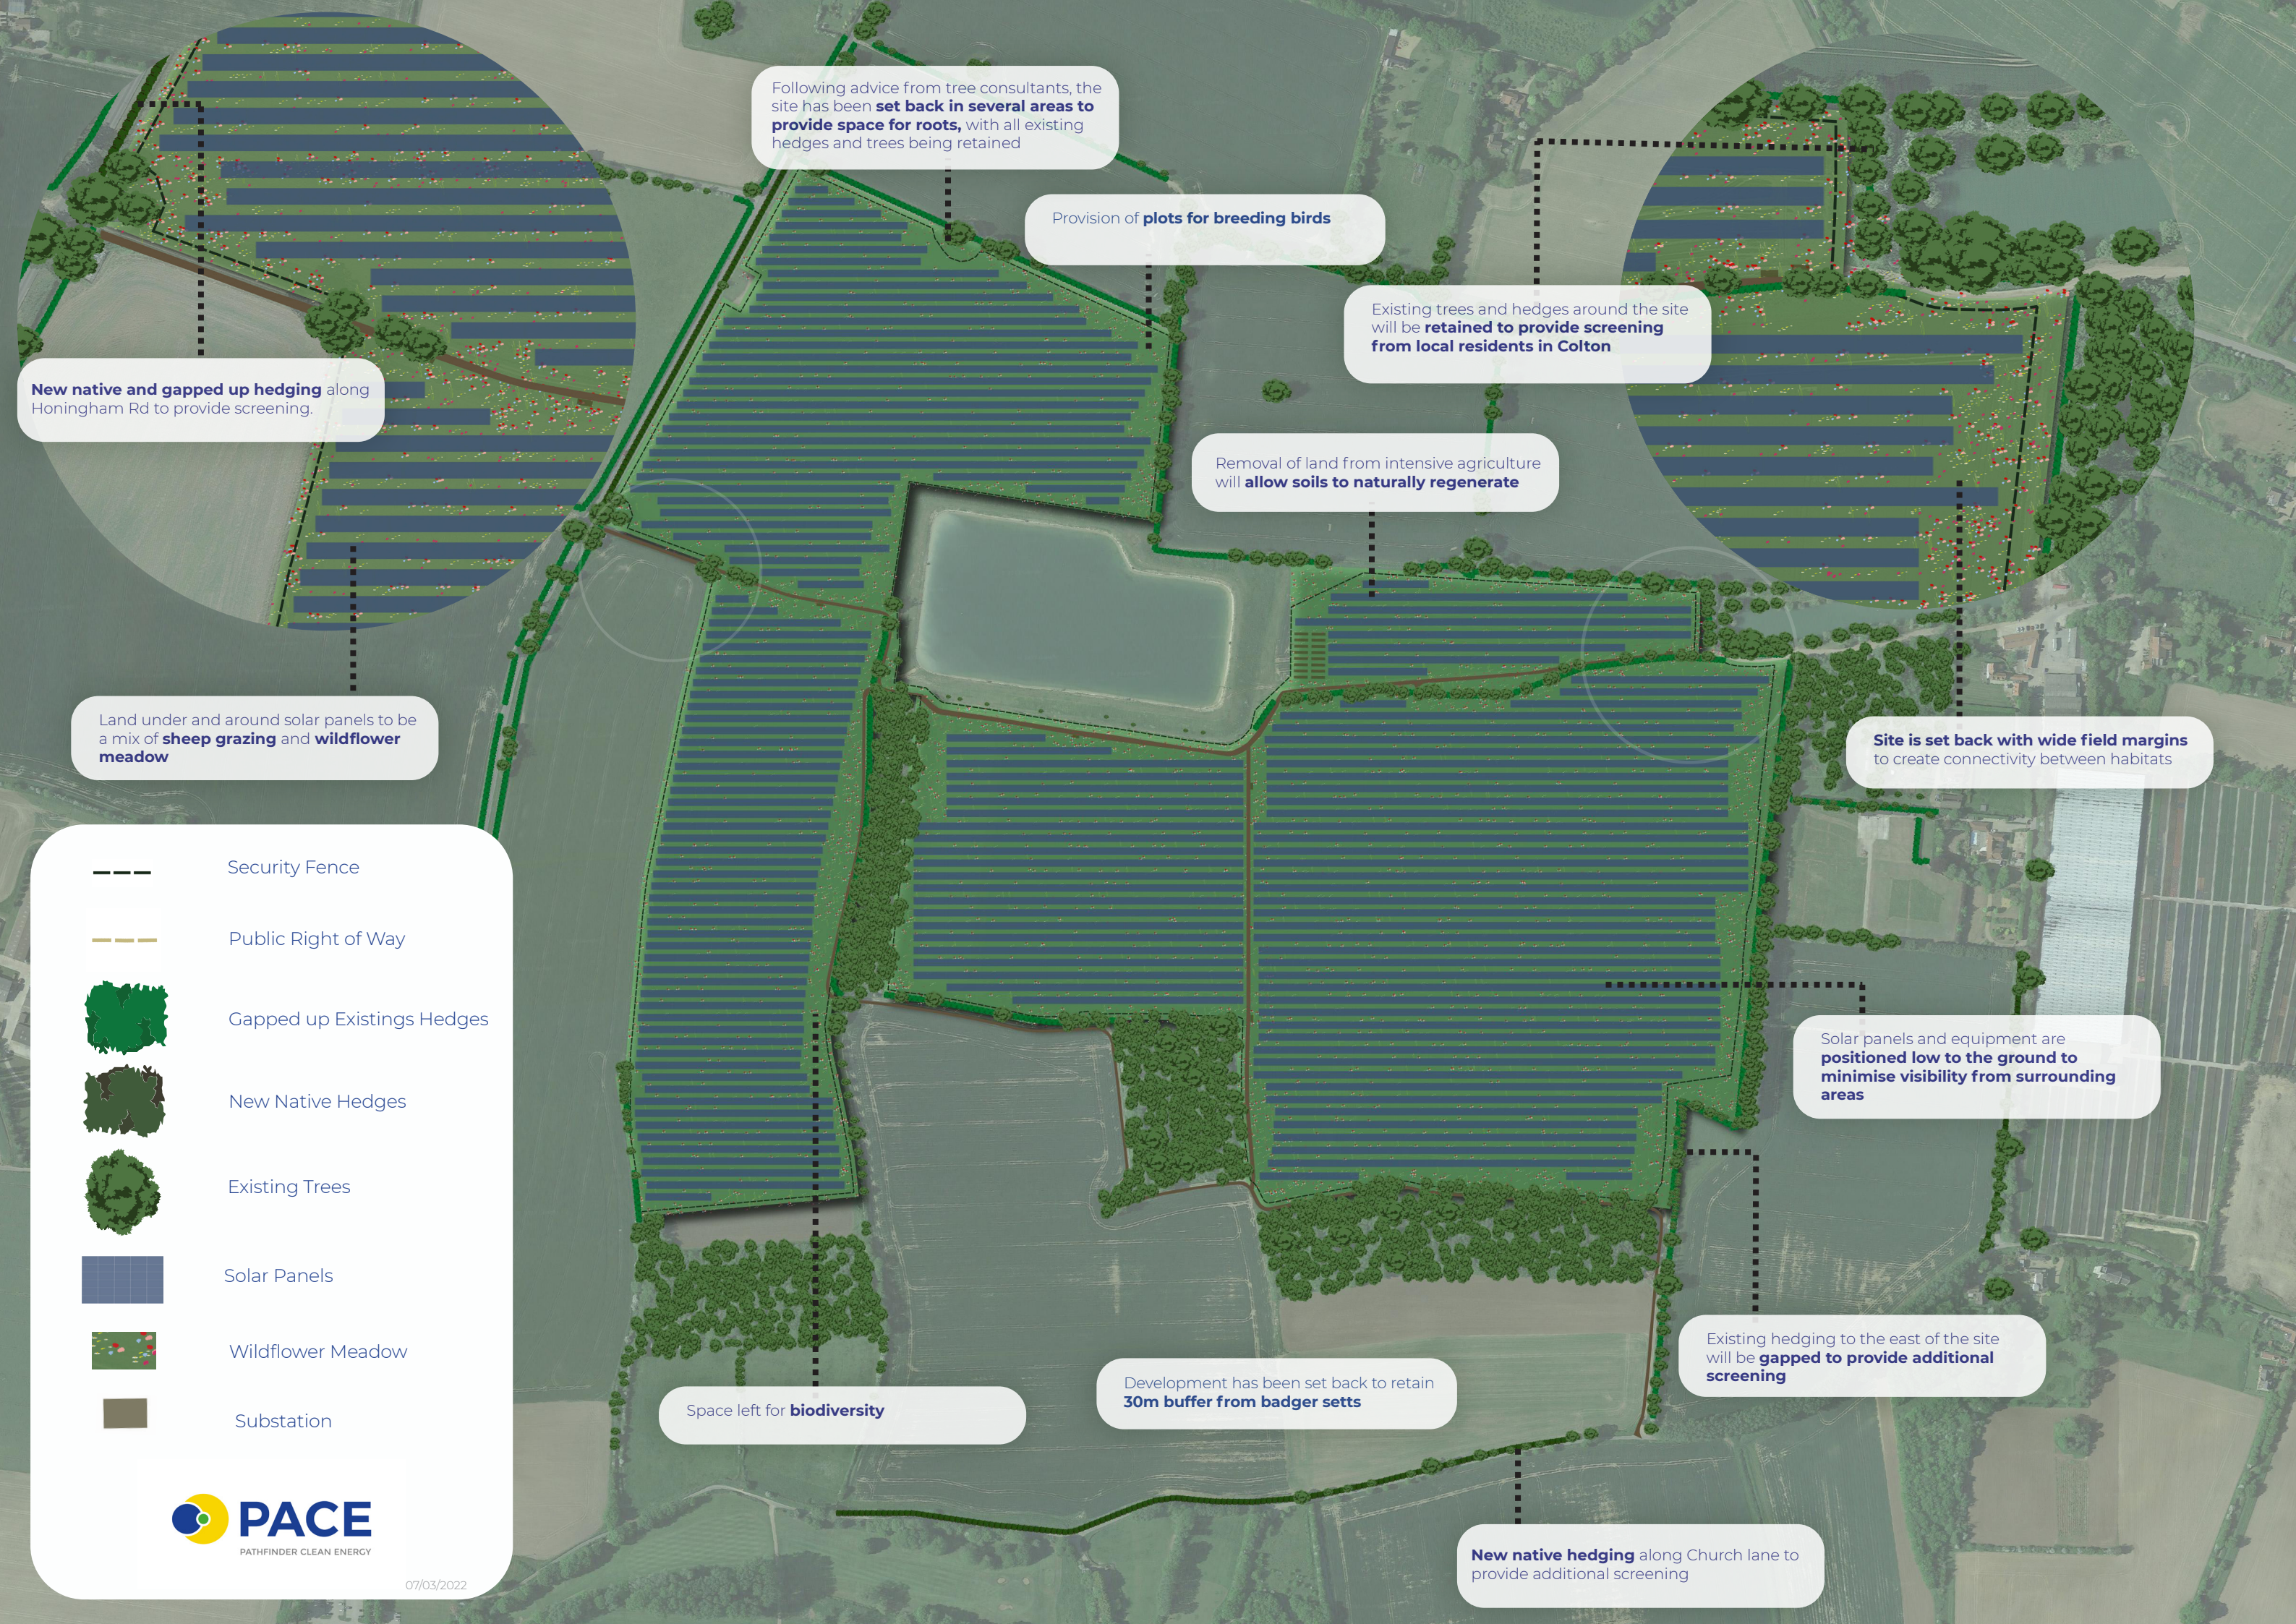
Following advice from tree consultants, the site has been **set back in several areas to provide space for roots**, with all existing hedges and trees being retained

Provision of **plots for breeding birds**

Existing trees and hedges around the site will be **retained to provide screening from local residents in Colton**

Removal of land from intensive agriculture will **allow soils to naturally regenerate**

**New native and gapped up hedging** along Honingham Rd to provide screening.

Land under and around solar panels to be a mix of **sheep grazing** and **wildflower meadow**

**Site is set back with wide field margins** to create connectivity between habitats

Solar panels and equipment are **positioned low to the ground to minimise visibility from surrounding areas**

Existing hedging to the east of the site will be **gapped to provide additional screening**

**New native hedging** along Church lane to provide additional screening

Development has been set back to retain **30m buffer from badger setts**

Space left for **biodiversity**
